Page No.
ABSTRACT	v
1. Summary	1
2. Introduction	2
3. Module Design	2
3.1 General Description	2
3.2 Solar Cell	2
3.3 Interconnects/Wiring	2
3.4 Superstrate	7
3.5 Pottant	7
3.6 Weather Barrier	7
3.7 Edge Seal/Insulation	7
3.8 Roof Mounting	8
4. Module Nominal Electrical Performance	8
5. Block V Qualification Tests	11
5.1 Test Procedures	11
5.2 Block V Group I Module Test Results	11
5.2.1 Thermal Cycling	11
5.2.2 Hi Potential/Continuity	12
5.2.3 Humidity Freeze	12
5.2.4 Mechanical Loading	12
5.2.5 Twisted Mount, Hotspot, Final Hi Potential	12
5.3 Block V Group II Module Test Results	12
5.3.1 Actual Module Electrical Performance	12
5.3.2 Thermal Cycling	13
5.3.3 Hi Potential/Continuity	13
5.3.4 Humidity Freeze	13
5.3.5 Mechanical Loading	13
5.3.6 Twisted Mount, Hotspot, Final Hi Potential	13
6. Module Design Changes	14
7. Conclusions and Recommendations	14

1.	Interface Control Ra180-12 Module	3
2.	Assembly Drawing Ra180-12 Module 1 of 2	4
3.	Assembly Drawing Ra180-12 Module 2 of 2	5
4.	Redundant Bus Solar Cell 1.885 x 3.735	6
5.	East-West View Integral Mounting	9
6.	North-South View Integral Mounting	10

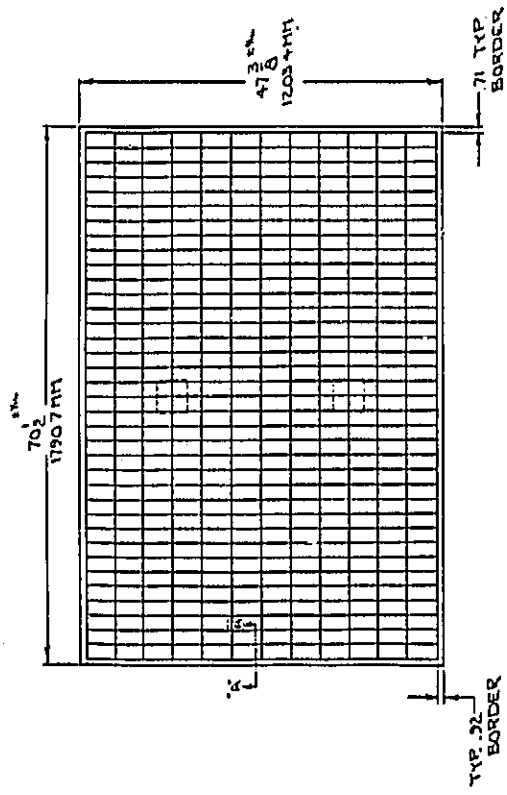
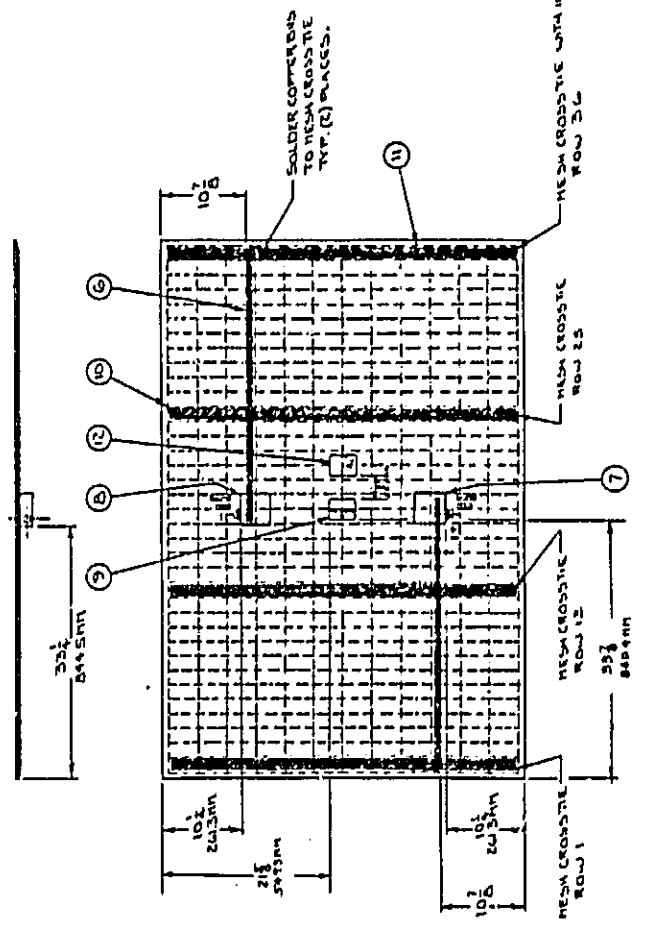
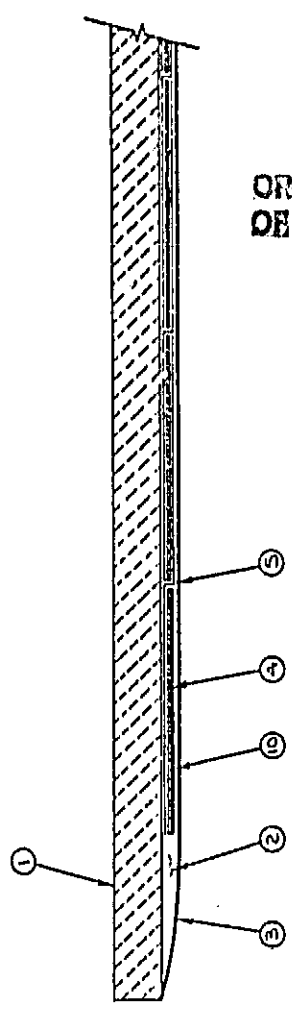
Model Type: Solar Energy Corporation  
 ASSEMBLY DRAWING  
 14180-12 MODULE

SECTION A-A  
 SCALE: 4 TO 1

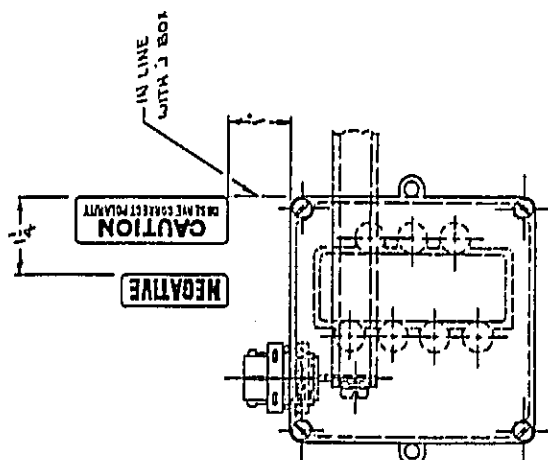
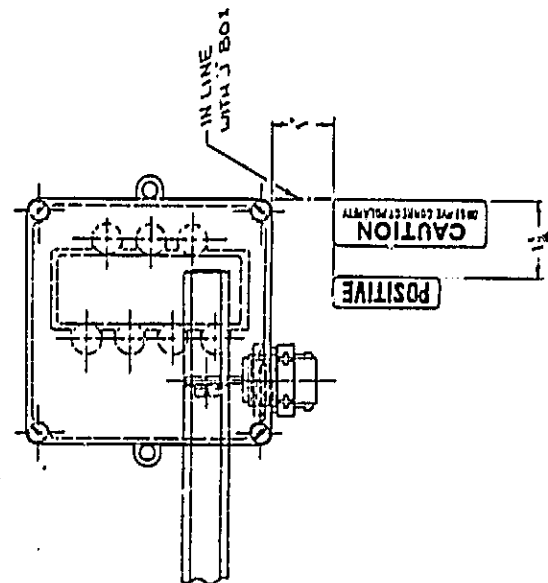
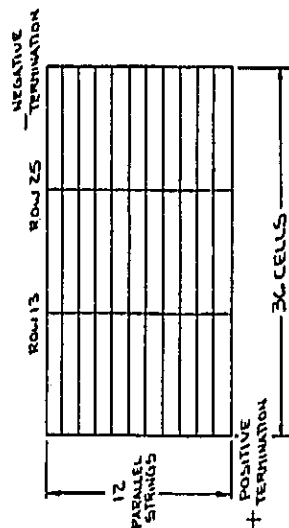
STRING INTERCONNECTION AND  
CROSS TIE BACK VIEW

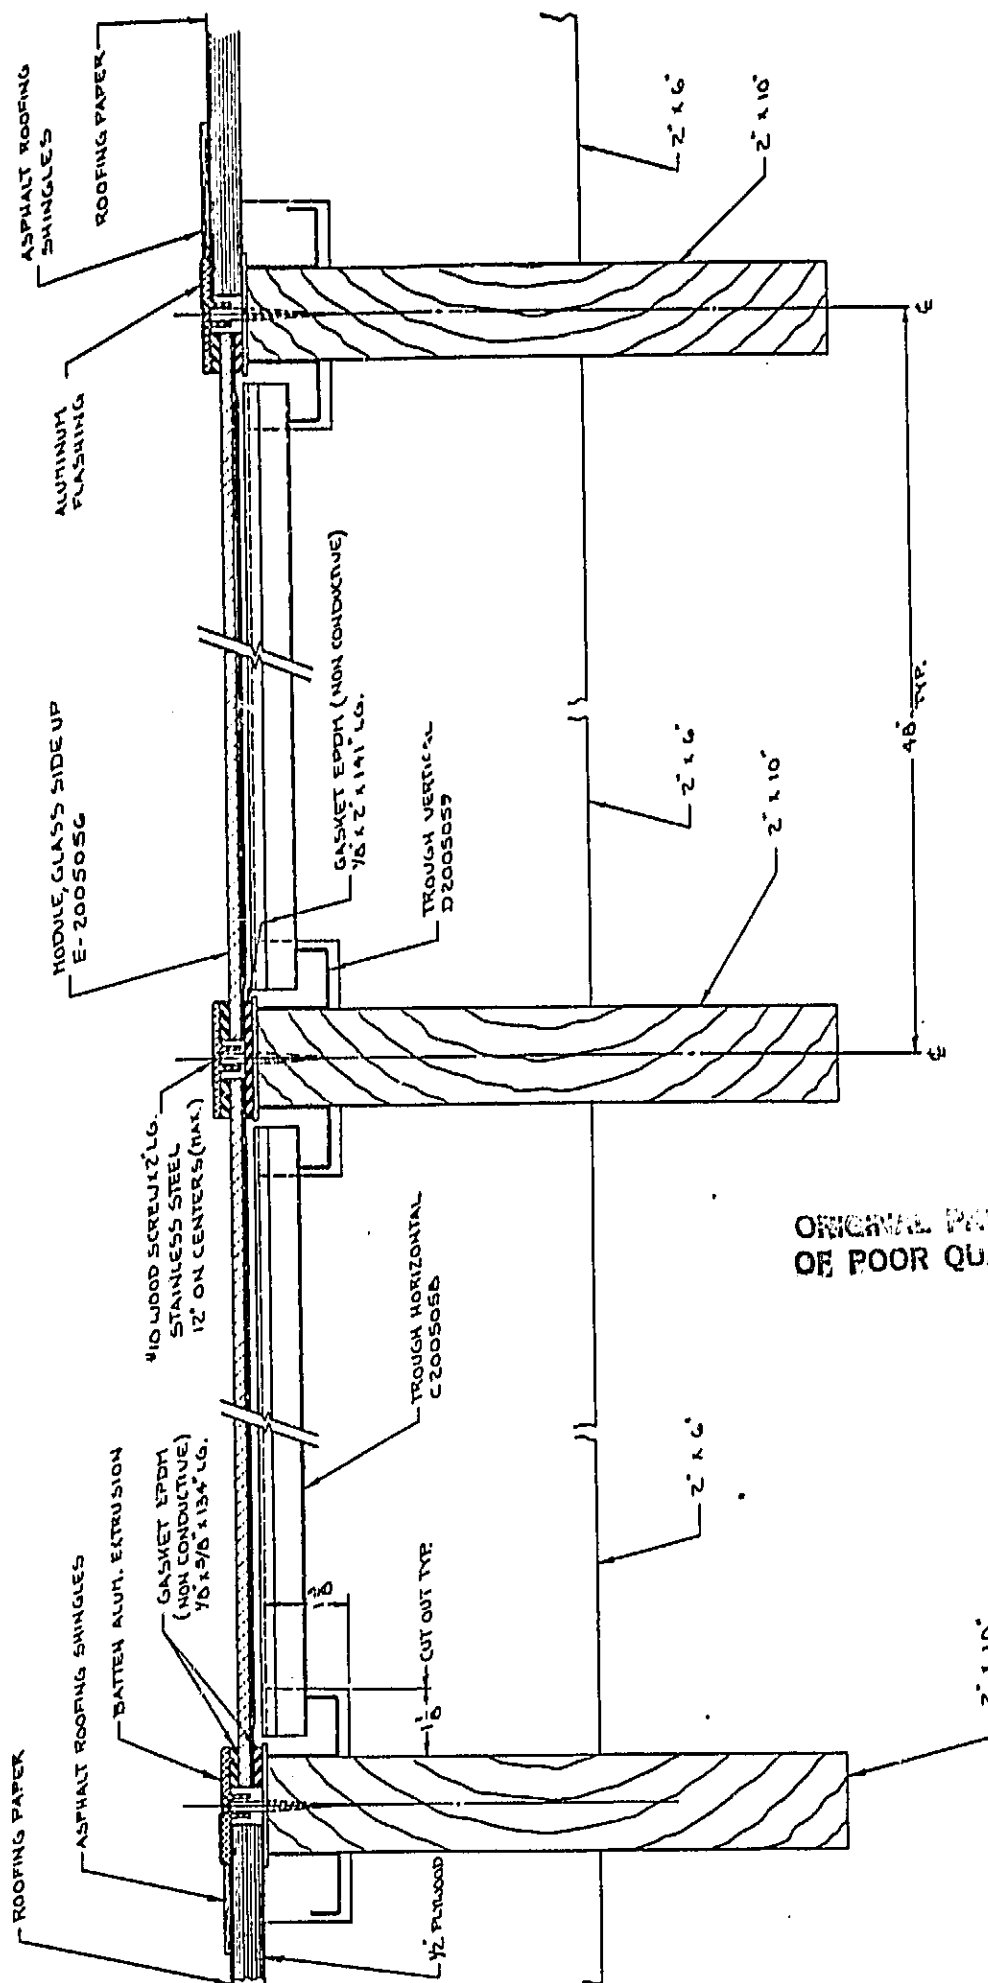
<b>Model 1100</b> <b>Solar Energy Corporation</b>		DATE: <u>10/1/81</u> DRAWN BY: <u>W. J. B.</u> CHECKED BY: <u>W. J. B.</u>
<b>INTEGRAL MOUNTING</b> <b>NORTH-SOUTH VIEW</b>		SCALE: <u>1/4" = 1'-0"</u> SHEET: <u>1</u> OF <u>1</u>
THIS DRAWING SPECIFICALLY REFERS TO THE FOLLOWING SPECIFICATIONS:		MATERIALS: ALUMINUM: <u>6061-T6</u> GLASS: <u>1/4" THICK</u> EPDM: <u>1/8" THICK</u> STEEL: <u>1/2" THICK</u> PLYWOOD: <u>1/2" THICK</u> ASPHALT: <u>30 YEAR</u> ROOFING: <u>SHINGLES</u>
THESE DIMENSIONS ARE BASED ON THE FOLLOWING ASSUMPTIONS:		1. ALL DIMENSIONS ARE IN INCHES 2. ALL DIMENSIONS ARE TO FACE 3. ALL DIMENSIONS ARE TO CENTER 4. ALL DIMENSIONS ARE TO EDGE 5. ALL DIMENSIONS ARE TO SURFACE 6. ALL DIMENSIONS ARE TO CENTER 7. ALL DIMENSIONS ARE TO FACE 8. ALL DIMENSIONS ARE TO CENTER 9. ALL DIMENSIONS ARE TO FACE 10. ALL DIMENSIONS ARE TO CENTER

### 3.8. ROOF MOUNTING (Figures 5 and 6)

Non-conductive gasketing is used around the perimeter of the module as a weather seal and cushion; however, in the event of a leak, drip troughs installed directly over the rafters and purlins will channel water harmlessly to the outside. A silicone RTV is used across the top and bottom of the module as a seal between modules.
